**Flood Control Project Maintenance
Levee Inspections**
LMA District Cover Sheet
Spring 2020 Levee Inspection Results

Sacramento River West Side Levee District

Spring 2020 Levee Inspection Results

Waterway			Bank	Unit Miles
Unit No. 01 Sacramento River			Right	49.64
	Spring (March - May)	Summer (June - August)	(September - November) Fall	Winter (December - February)
Unit Maintenance Rating (Fall Only)				
Date of Inspection	3/24/2020 - 3/24/2020			
DWR Inspector	Zach Jojola			
Accompanied By	Gary Marler RD0108

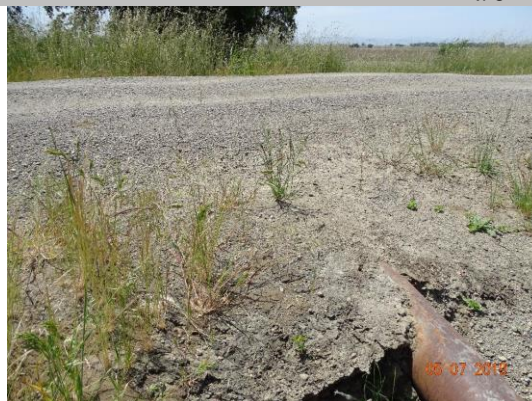
Photo 1 of 3 : UCIP_SP_2020_54061_79354.jpg

DS_ID:20307
FS_ID:54061
EP_NO: 1734
Repair Type: Urgent
Crossing Status: Found
UCIP Comments: 05/22/2019 Failed siphon breaker lets water out of pipe on WS slope that creates erosion around the pipe. Noticed multiple through holes in pipe outlet on river's edge. Owner is in process to apply for a permit to replace the pipe. (O.Yakimov - DWR UCIP)
Good candidate for video inspection as pipe is heavily rusted at outlet.
FIELD_STRUCT_DESC: 8-inch steel drainage pipe through the levee, 1 foot below the crown. One metal cutoff wall. Vertical pumping unit in drainage ditch at the landside (LS) toe. Siphon breaker on the waterside (WS) slope. (Permit No. 1734, 1953 - Davis Ranches).
[Additional Reference(s): DWR Levee Log, 1980. USACE Sacramento O&M Manual 131, May 1960 (HLM 37.95)].
FS Date: 5/22/2019 8:03:31 AM

View of levee crown at crossing

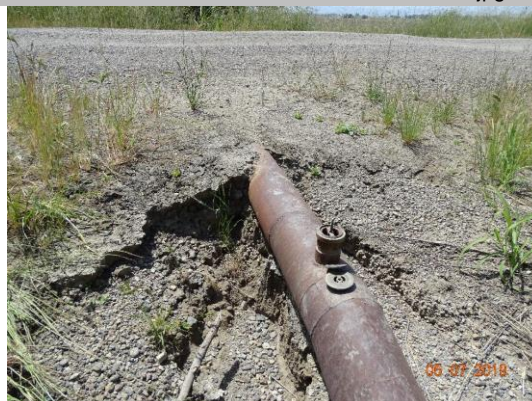
Photo 2 of 3 : UCIP_SP_2020_54061_79355.jpg

Erosion on WS slope

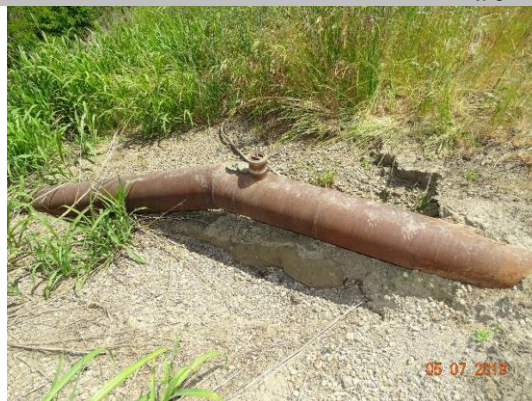
Photo 3 of 3 : UCIP_SP_2020_54061_79356.jpg

Erosion on WS slope around pipe

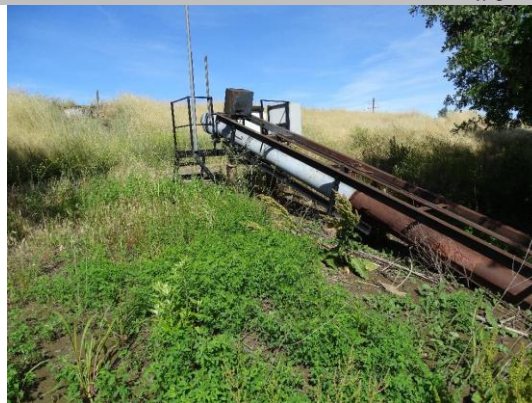
Photo 1 of 3 : UCIP_SP_2020_54177_79808.jpg

Comment Code						
Inspector Comment						
DS_ID:20277 FS_ID:54177 EP_NO: 9356 Repair Type: Non-Urgent Crossing Status: Found UCIP Comments: 05/22/2019 Cover missing on CMP riser WS. (O.Yakimov - DWR UCIP) FIELD_STRUCT_DESC: 1 of 5: 16-inch concrete encased steel irrigation pipe through the levee, 20 feet below the crown. Two concrete walls. Slant pump mounted on channel iron supports the waterside (WS) bank. Slide gate in 60-inch corrugated metal riser unit on the WS slope. Flap gate mounted in a concrete distribution box on the landside (LS). Water meter in 48-inch corrugated metal riser unit on the WS berm. (Automatic Board Order (ABO) issued as Permit No. 9356, 1974 - Annie D. Propfe). (Pipe installed by the United States Army Corps of Engineers, 1962). [Additional Reference(s): DWR Levee Log, 2006]. FS Date: 5/22/2019 1:06:22 PM

Pumping platform on WS berm

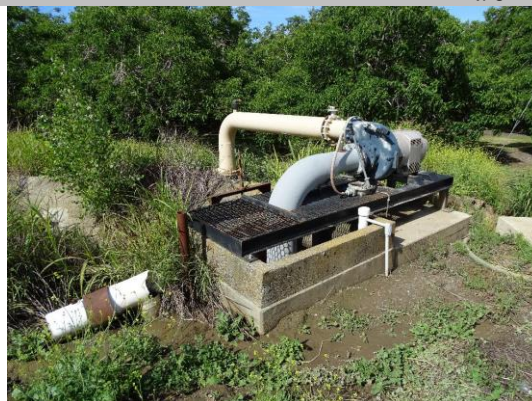
Photo 2 of 3 : UCIP_SP_2020_54177_79809.jpg

Pump at LS concrete distribution box

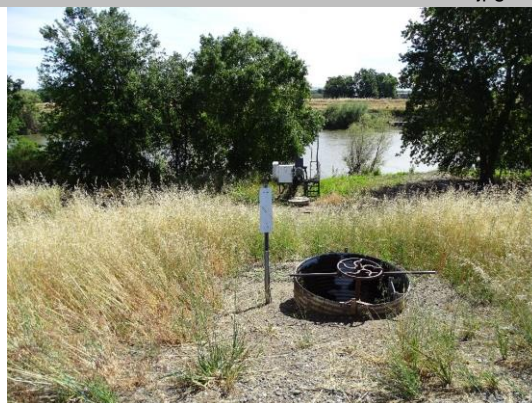
Photo 3 of 3 : UCIP_SP_2020_54177_79810.jpg

WS slope and CMP riser on the slope

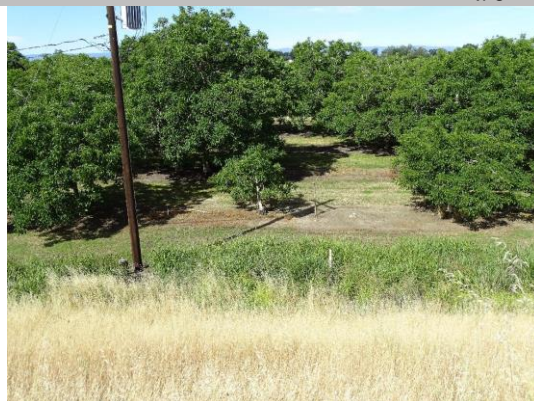
Photo 1 of 3 : UCIP_SP_2020_54179_79814.jpg

Comment Code						
Inspector Comment						
DS_ID:20322 FS_ID:54179 EP_NO: 4383A Repair Type: Non-Urgent Crossing Status: Found UCIP Comments: 05/22/2019 Record updated from No Action Needed to Non-Urgent. No records available to determine status of line. (O.Yakimov - DWR UCIP) FIELD_STRUCT_DESC: 8.625-inch gas pipeline of an unknown material through the levee, 3.5 feet below the crown. Concrete cutoff wall. Gas line markers on landside (LS) toe and waterside (WS) shoulder. Pipe crosses channel. (8-5/8-inch line authorized under Permit No. 4383-A, 1963 - PG&E). [Additional Reference(s): DWR Levee Log, 2006 (HLM 38.97)]. FS Date: 5/22/2019 3:39:18 PM

View of LS slope. Gasline marker at LS toe near power pole

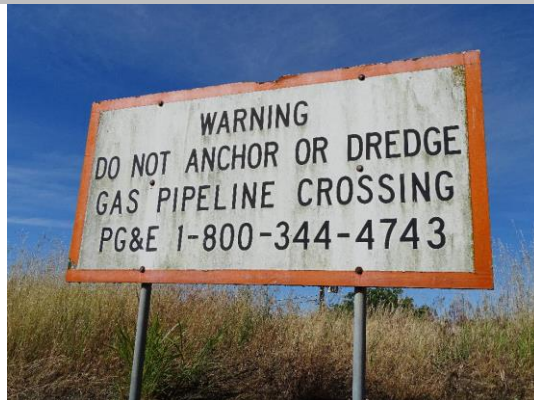
Photo 2 of 3 : UCIP_SP_2020_54179_79815.jpg

Large gasline marker sign on WS shoulder

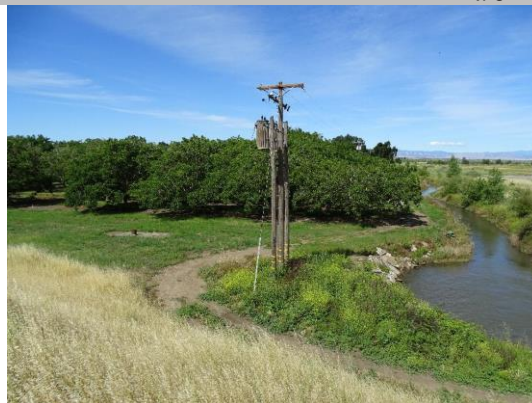
Photo 1 of 3 : UCIP_SP_2020_54192_79829.jpg

LM Start	38.72	Rating **	M	Issue No.	1650
LM End	38.72	Issue Type +	En	Location *	
Category	Supplemental			GPS Latitude/Longitude	
				Start	End
Item	DWR UCIP Field Study			39.136796 °	39.136796 °
				-121.940299 °	-121.940299 °
DWR ID	22964				
Comment Code					
Inspector Comment					
DS_ID:22964 FS_ID:54192 EP_NO: 9356 Repair Type: Non-Urgent Crossing Status: Found UCIP Comments: 05/22/2019 No issues recorded during inspection (O.Yakimov - DWR UCIP) FIELD_STRUCT_DESC: 3-inch galvanized steel electrical conduit through the levee, at an unknown depth. Provides power for a pumping plant on the waterside (WS) slope. FS Date: 5/22/2019 9:02:14 AM

Power pole on LS

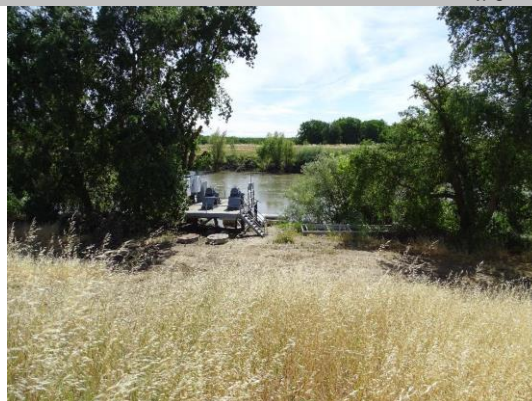
Photo 2 of 3 : UCIP_SP_2020_54192_79830.jpg

Pumping platform of WS berm

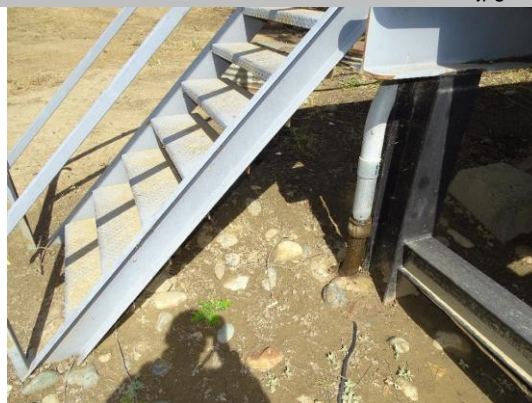
Photo 3 of 3 : UCIP_SP_2020_54192_79831.jpg

Conduit comes out of the ground near pumping platform

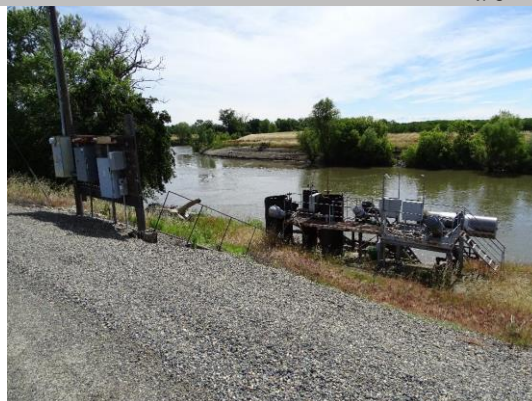
Photo 1 of 3 : UCIP_SP_2020_54197_79845.jpg

LM Start	39.18	Rating **	M	Issue No.	1653
LM End	39.18	Issue Type +	En	Location *	
Category	Supplemental			GPS Latitude/Longitude	
				Start	End
Item	DWR UCIP Field Study			39.143261 °	39.143261 °
				-121.939707 °	-121.939707 °
DWR ID	20279				
Comment Code					
Inspector Comment					
DS_ID:20279 FS_ID:54197 EP_NO: N/A Repair Type: Non-Urgent Crossing Status: Found UCIP Comments: 05/22/2019 No issues recorded during inspection (O.Yakimov - DWR UCIP) FIELD_STRUCT_DESC: 1 of 2: 3-foot by 6-foot reinforced concrete box irrigation tunnel through the levee, 27.5 feet below the crown. (Tunnels installed in 1916, but mentioned in Permit No. 3278, 1960 - Olive Percy Daris). Pipes tie into tunnels at standpipes on the waterside (WS) toe. [Additional Reference(s): DWR Levee Log, 2006]. FS Date: 5/22/2019 10:51:45 AM

Pumping platform at WS toe

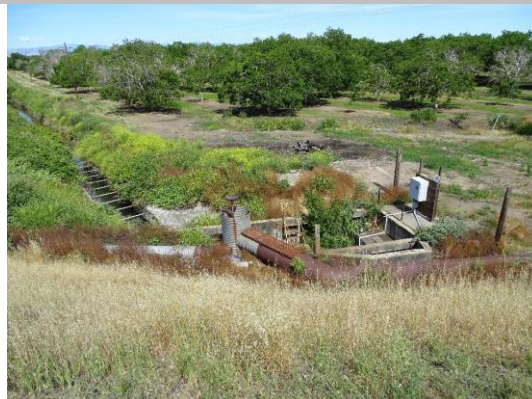
Photo 3 of 3 : UCIP_SP_2020_54197_79846.jpg

LS slope with crossing appurtenances

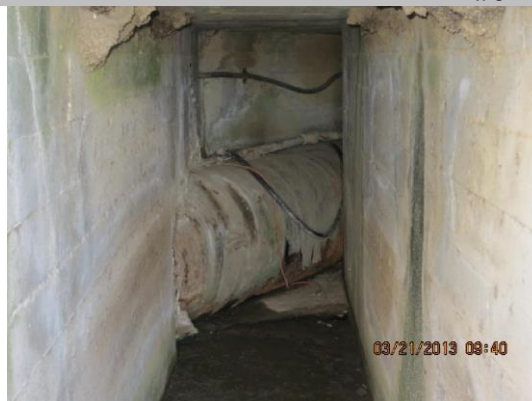
Photo 1 of 3 : UCIP_SP_2020_54201_17802.jpg

DS_ID:20418
 FS_ID:54201
 EP_NO: N/A
 Repair Type: Non-Urgent
 Crossing Status: Found
 UCIP Comments: 05/22/18 Permit not available (O.Yakimov - DWR UCIP)
 FIELD_STRUCT_DESC: 2 of 2: 3-foot by 6-foot reinforced concrete box irrigation tunnel through the levee, 27.5 feet below the crown. Pipe runs through concrete tunnel. Tunnel installed in 1916. (Mentioned in Permit No. 3278, 1960 - Olive Percy Davis). [Additional Reference(s): DWR Levee Log, 2006].
 FS Date: 5/22/2019 2:08:00 PM

Pipe running through 3'X6' concrete tunnel at LS.

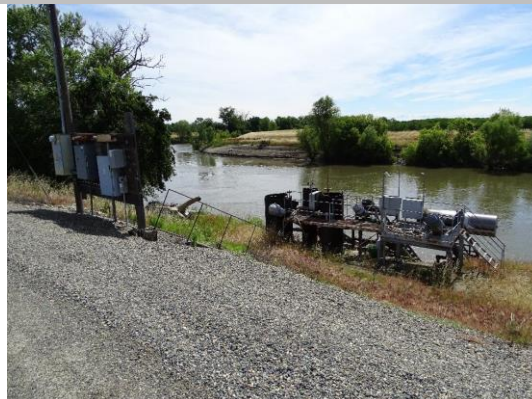
Photo 2 of 3 : UCIP_SP_2020_54201_79864.jpg

Pumping platform on WS berm

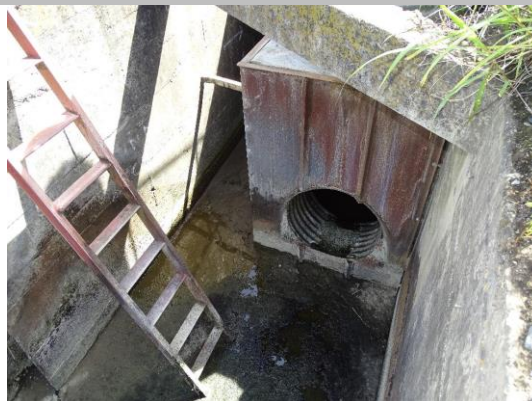
Photo 3 of 3 : UCIP_SP_2020_54201_79865.jpg

Concrete tunnel opens in concrete structure on LS

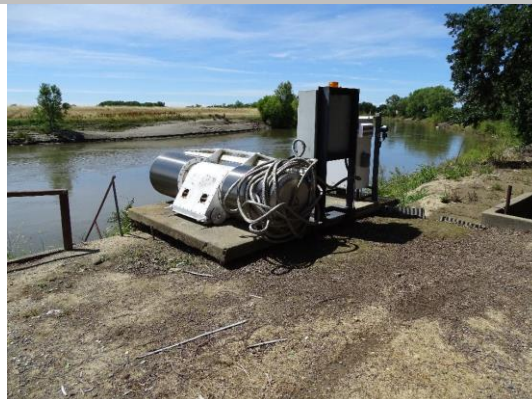
Photo 1 of 3 : UCIP_SP_2020_54203_79868.jpg

LM Start	39.33	Rating **	M	Issue No.	1655	
LM End	39.33	Issue Type +	En	Location *		
Category	Supplemental			GPS Latitude/Longitude		
				Start	End	
Item	DWR UCIP Field Study			39.144834 °	39.144834 °	
				-121.937892 °	-121.937892 °	
DWR ID	22965					
Comment Code						
Inspector Comment						
DS_ID:22965 FS_ID:54203 EP_NO: 9341 Repair Type: Non-Urgent Crossing Status: Found UCIP Comments: 05/22/2019 No issues recorded during inspection (O.Yakimov - DWR UCIP) FIELD_STRUCT_DESC: 2-inch electrical conduit of an unknown material through the levee, at an unknown depth. Provides power for pump on waterside (WS) berm. FS Date: 5/22/2019 2:45:10 PM

Pump on WS berm

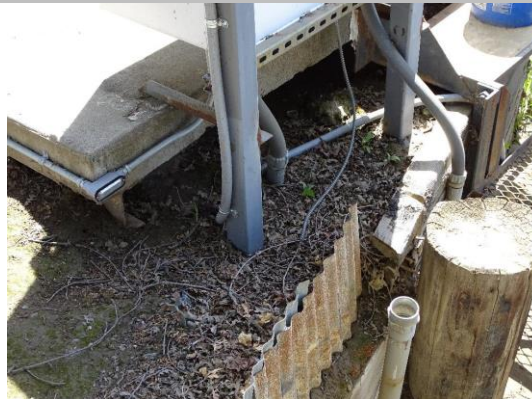
Photo 2 of 3 : UCIP_SP_2020_54203_79869.jpg

Conduit coming out of ground at pumping platform

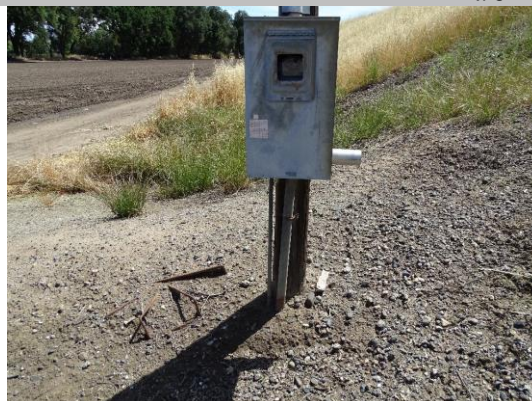
Photo 3 of 3 : UCIP_SP_2020_54203_79870.jpg

Electical panel and conduit at service pole

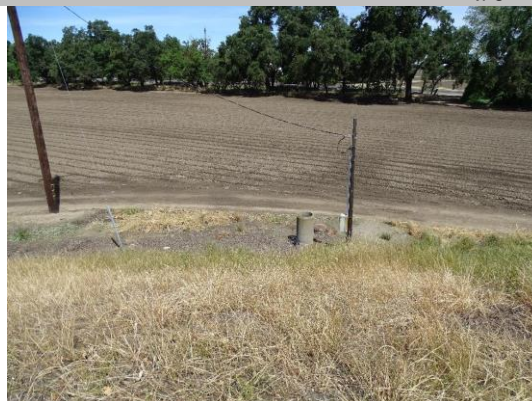
Photo 1 of 3 : UCIP_SP_2020_54204_79873.jpg

DS_ID:20280
 FS_ID:54204
 EP_NO: 9341
 Repair Type: Non-Urgent
 Crossing Status: Found
 UCIP Comments: 05/22/2019 Pipe between pump and riverbank was replaced. (O.Yakimov - DWR UCIP)
 FIELD_STRUCT_DESC: 24-inch reinforced concrete irrigation pipe through the levee, 21 feet below the crown. Slide gate on the waterside (WS) end in a concrete surge box with flap gates. Pump platform on the WS berm. Pipe discharges into a concrete riser at the toe of the landside (LS) slope. (Automatic Board Order (ABO) issued as Permit No. 9341, 1974 - F. J. Steidlmyer). [Additional Reference(s): DWR Levee Log, 2006. USACE Sacramento O&M Manual 131, May 1960 (HLM 39.82)].
 FS Date: 5/22/2019 2:46:43 PM

LS slope at crossing. Concrete standpipe at LS toe

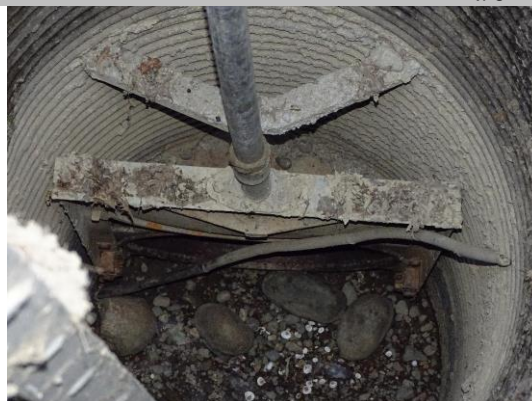
Photo 2 of 3 : UCIP_SP_2020_54204_79874.jpg

Inside view of concrete standpipe. Debris at the bottom

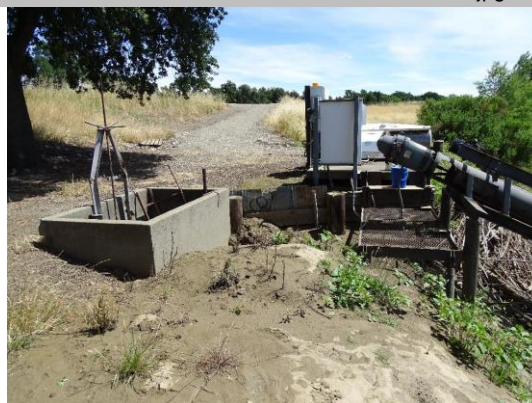
Photo 3 of 3 : UCIP_SP_2020_54204_79877.jpg

Surge box and pump on WS berm

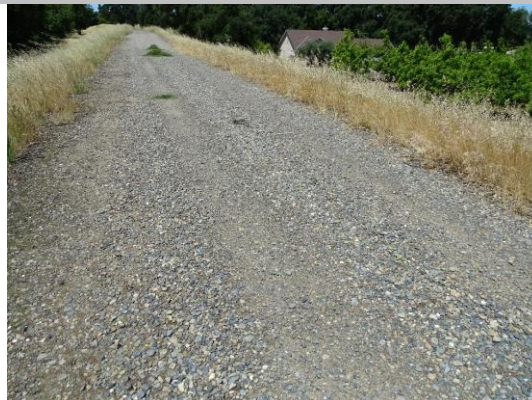
Photo 1 of 3 : UCIP_SP_2020_54207_79878.jpg

Comment Code						
Inspector Comment						
DS_ID:20282 FS_ID:54207 EP_NO: 635 Repair Type: Non-Urgent Crossing Status: Found UCIP Comments: 05/22/2019 Water is high, no pipe visible at riverbank. (O.Yakimov - DWR UCIP)03/21/2013 Pipe appears to have been removed from levee section. Need to verify pipe abandonment. FIELD_STRUCT_DESC: 12-inch steel irrigation pipe through the levee, 5 feet below the crown. Switch house on the waterside (WS) shoulder. Pump and gate valve on the WS bank. Concrete discharge standpipe on the landside (LS). (For a 14-inch pipe, Permit No. 635, 1935 - Henry F. Schmidt). (Automatic Board Order (ABO) issued as Permit No. 9351, 1974 - W. A. Gerrans). [Additional Reference(s): DWR Levee Log, 2006. USACE Sacramento O&M Manual 131, May 1960 (HLM 40.43)]. FS Date: 5/22/2019 8:16:21 AM

Levee crown at crossing

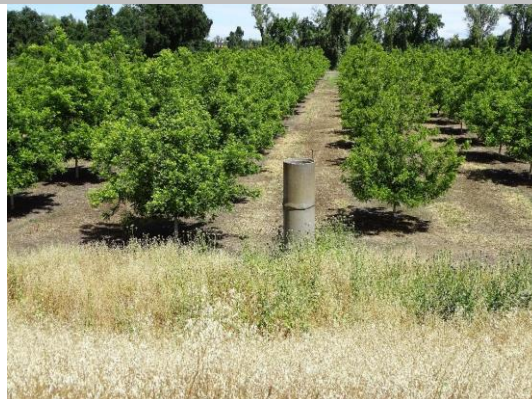
Photo 2 of 3 : UCIP_SP_2020_54207_79879.jpg

Concrete standpipe at LS toe

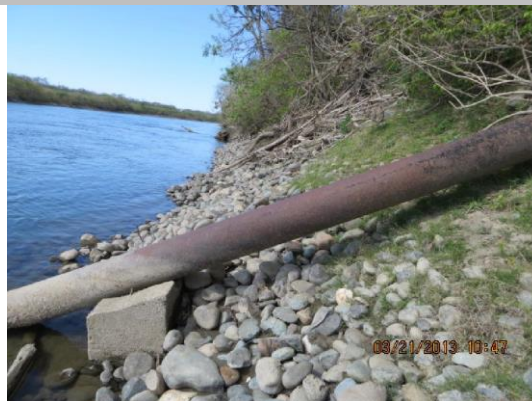
Photo 3 of 3 : UCIP_SP_2020_54207_17853.jpg

Pipe visible at WS toe.

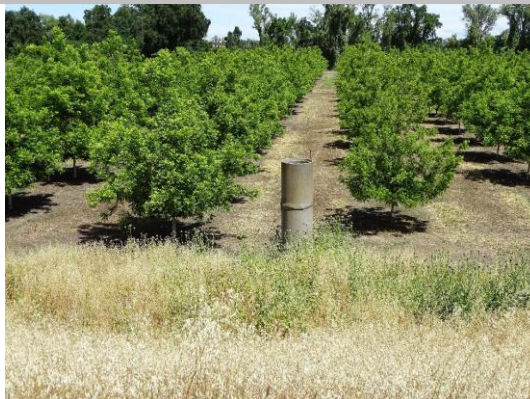
Photo 1 of 2 : UCIP_SP_2020_54208_79881.jpg

DS_ID:22966
 FS_ID:54208
 EP_NO: 9352
 Repair Type: Non-Urgent
 Crossing Status: Found
 UCIP Comments: 05/22/2019 Conduit is visible in LS slope.
 (O.Yakimov - DWR UCIP)03/21/2013 Pipe should be removed.
 FIELD_STRUCT_DESC: 1.5-inch galvanized steel electrical conduit
 through the levee, at an unknown depth. Visible on the waterside (WS)
 slope. (Permit No. 635, 1935 - Henry F. Schmidt).
 FS Date: 5/22/2019 8:25:07 AM

Electrical conduit approximately perpendicular to concrete riser on LS toe

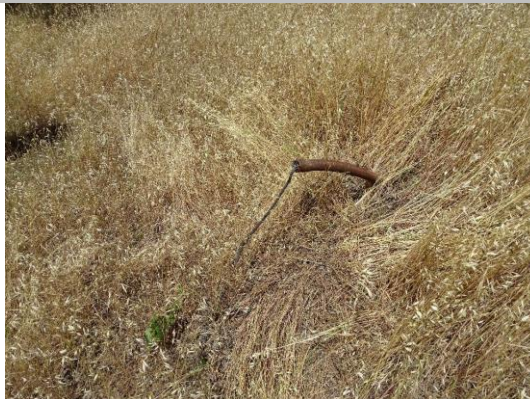
Photo 2 of 2 : UCIP_SP_2020_54208_79882.jpg

Electical conduit on WS slope

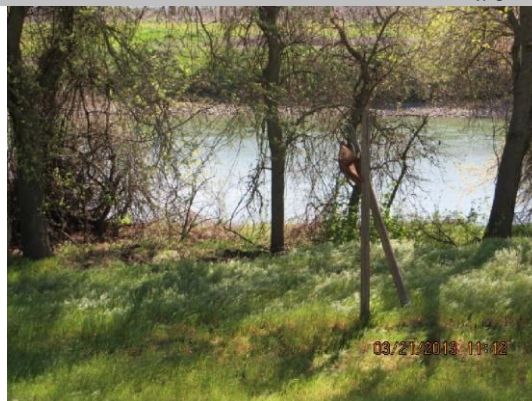
Photo 1 of 1 : UCIP_SP_2020_54209_17855.jpg

LM Start	40.36	Rating **	M	Issue No.	1660	
LM End	40.36	Issue Type +	En	Location *		
Category	Supplemental			GPS Latitude/Longitude		
				Start	End	
Item	DWR UCIP Field Study			39.142602 °	39.142602 °	
				-121.919804 °	-121.919804 °	
DWR ID	20283					
Comment Code						
Inspector Comment						
DS_ID:20283 FS_ID:54209 EP_NO: 1508 Repair Type: Non-Urgent Crossing Status: Indicator Found UCIP Comments: 05/22/2019 Unable to locate a sign on WS berm. Crossing alignment needs markers. (O.Yakimov - DWR UCIP) FIELD_STRUCT_DESC: 4-inch telephone cable of an unknown material through the levee, 4 feet below the crown. Old rusty sign at waterside (WS) toe of levee. (Permit No. 1508, 1950 - PT&T). [Additional Reference(s): DWR Levee Log, 2006]. FS Date: 5/22/2019 8:41:06 AM

rusty sign on WS toe.

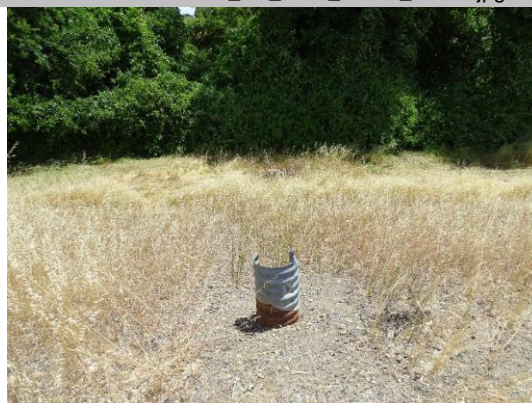
Photo 1 of 3 : UCIP_SP_2020_54212_79888.jpg

Comment Code					
Inspector Comment					
DS_ID:20285 FS_ID:54212 EP_NO: 12799 Repair Type: Non-Urgent Crossing Status: Found UCIP Comments: 05/22/2019 Pipe is capped at WS toe. If pipe is abandoned then should be done properly. (O.Yakimov - DWR UCIP)03/21/2013 Pipe appears abandoned. Need to verify type of abandonment FIELD_STRUCT_DESC: 18-inch steel irrigation pipe through the levee, 6.5 feet below the crown. 30-inch corrugated metal standpipe on landside (LS) toe. Pump on the waterside (WS) toe. Vent inside a 12-inch corrugated metal riser unit on the WS shoulder. (Permit No. 12799, 1979 - Bruce Myers). [Additional Reference(s): DWR Levee Log, 2006]. FS Date: 5/22/2019 10:13:13 AM

12-inch CMP riser on WS shoulder

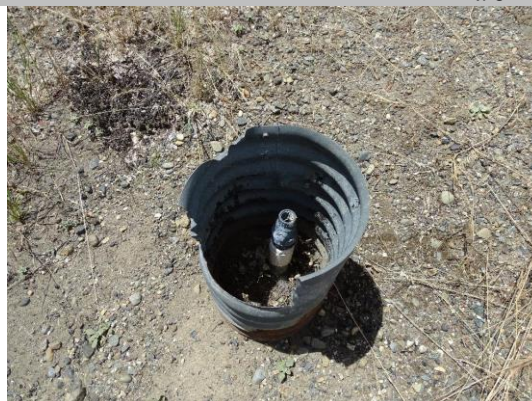
Photo 2 of 3 : UCIP_SP_2020_54212_79891.jpg

Air vent in CMP riser on WS shoulder

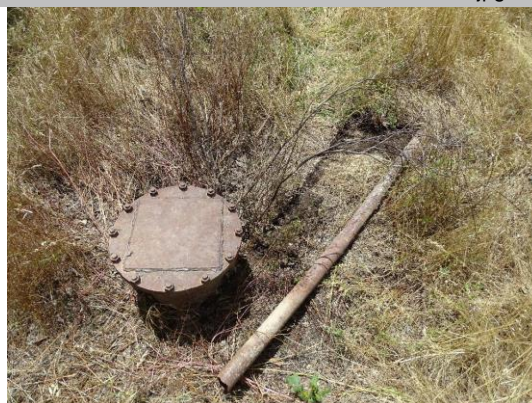
Photo 3 of 3 : UCIP_SP_2020_54212_79889.jpg

Bolted cap over pipe at WS toe

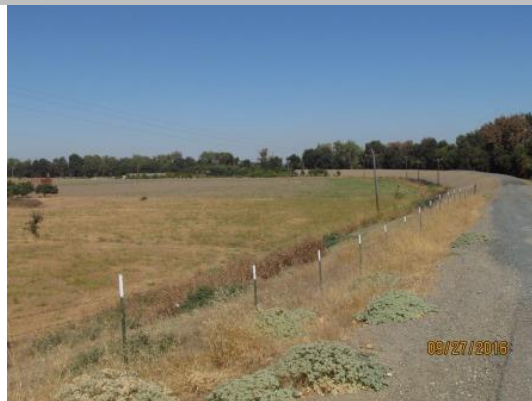
Photo 1 of 1 : SP_2020_NA0016_435_102_20200228_00033.jpg

LM Start	40.64	Rating **	M	Issue No.	102
LM End	40.72	Issue Type +	En	Location *	LS
Category	Earthen Levee			GPS Latitude/Longitude	
				Start	End
Item	Encroachments			39.146602 °	39.147582 °
				-121.918897 °	-121.918429 °
DWR ID	DWR_NA0016_01_s_2015_102				
Comment Code					
FE : Fence					
Inspector Comment

View of owner's fence on landside. Fall 2016 inspection.

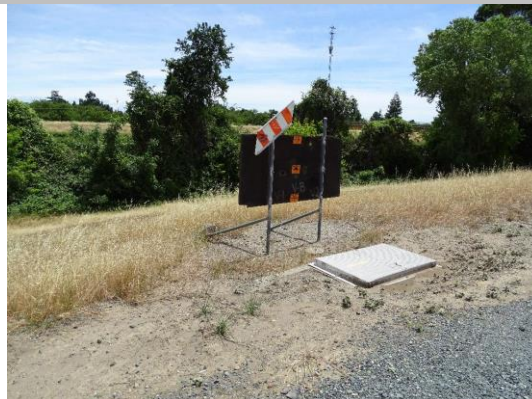
Photo 1 of 3 : UCIP_SP_2020_54213_79892.jpg

DS_ID:20318
FS_ID:54213
EP_NO: N/A
Repair Type: Non-Urgent
Crossing Status: Indicator Found
UCIP Comments: 05/22/2019 Crossing has a missing permit.
(O.Yakimov - DWR UCIP)
FIELD_STRUCT_DESC: 3-inch steel gas pipeline through the levee,
4.0 feet below the crown. Concrete vault and sign on the waterside
(WS) shoulder.
FS Date: 5/22/2019 11:01:31 AM

Gasline markers and concrete vault on WS shoulder

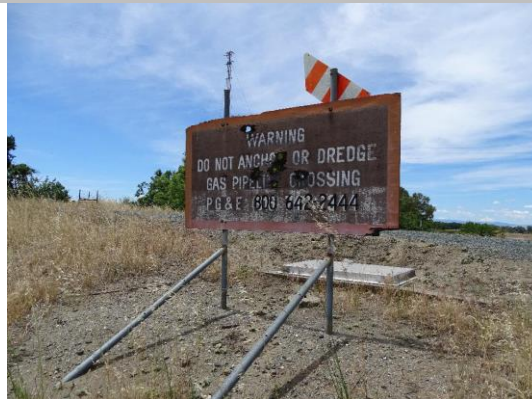
Photo 2 of 3 : UCIP_SP_2020_54213_79893.jpg

Gasline sign on WS slope

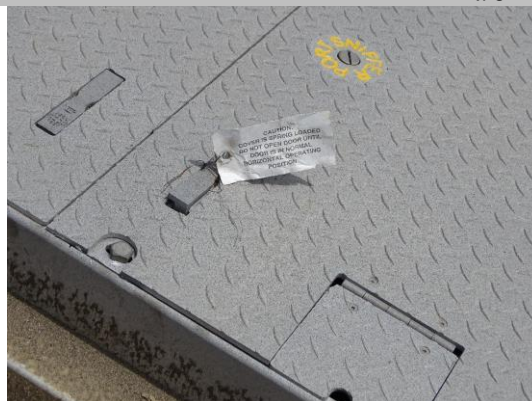
Photo 3 of 3 : UCIP_SP_2020_54213_79894.jpg

Warning tag on vault cover

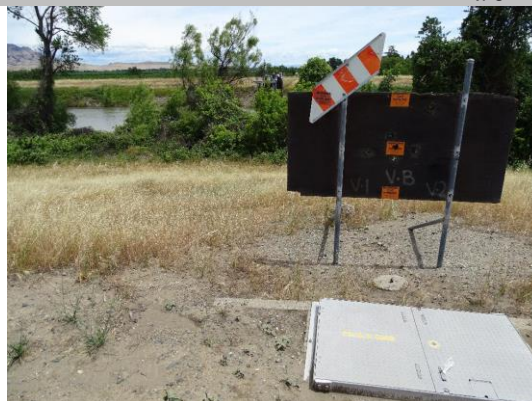
Photo 1 of 3 : UCIP_SP_2020_54214_79895.jpg

DS_ID:20286
 FS_ID:54214
 EP_NO: 767
 Repair Type: Non-Urgent
 Crossing Status: Indicator Found
 UCIP Comments: 05/22/2019 Record was updated from No Action Needed to Non-Urgent. No records are available to determine status of line. (O.Yakimov - DWR UCIP)
 FIELD_STRUCT_DESC: 3-inch steel gas line through the levee, 4 feet below the crown. Concrete inspection chamber and sign on the waterside (WS) shoulder. (Gas line is authorized under permit No. 767, 1938 - Pacific Gas & Electric Company [PG&E]). [Additional Reference(s): DWR Levee Log, 2006, HLM 41.18].
 FS Date: 5/22/2019 11:18:22 AM

Sign and concrete vault on WS shoulder

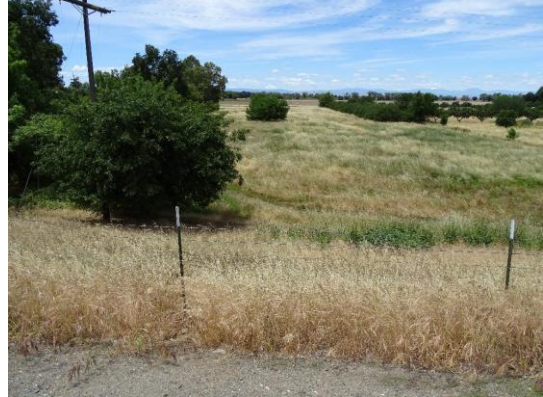
Photo 2 of 3 : UCIP_SP_2020_54214_79896.jpg

View of LS at crossing

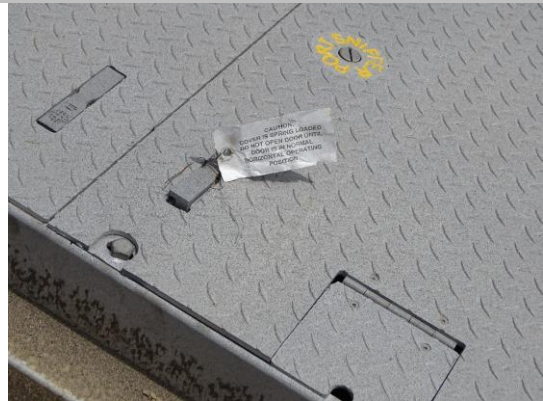
Photo 3 of 3 : UCIP_SP_2020_54214_79897.jpg

Warning tag on vault cover

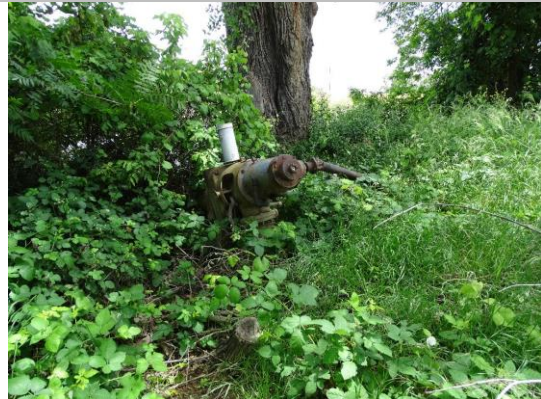
Photo 1 of 3 : UCIP_SP_2020_54215_79900.jpg

Comment Code						
Inspector Comment						
DS_ID:20287 FS_ID:54215 EP_NO: 9351 Repair Type: Non-Urgent Crossing Status: Found UCIP Comments: 05/22/2019 Damaged C-shaped concrete headwall at LS toe. Crossing looks abandoned. If not in use then should be abandoned properly. (O.Yakimov - DWR UCIP)03/21/2013 Appears abandoned. Should be abandoned properly. FIELD_STRUCT_DESC: 30-inch corrugated metal irrigation pipe through the levee, 17.5 feet below the crown. Slide gate on the waterside (WS) end. Discharges into a concrete box at the landside (LS) toe. Small pump discharges into a sump area in front of slide gate at WS toe. (Automatic Board Order (ABO) issued as Permit No. 9351, 1974 - W. A. Gerrans). [Additional Reference(s): DWR Levee Log, 2006. USACE Sacramento O&M Manual 131, May 1960 (HLM 41.39)]. FS Date: 5/22/2019 11:38:11 AM

Abandoned small pump on WS berm

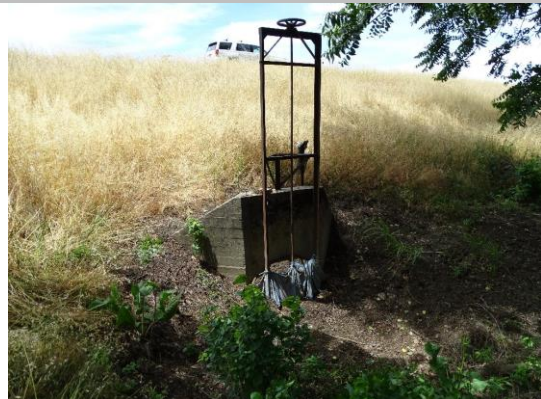
Photo 2 of 3 : UCIP_SP_2020_54215_79899.jpg

Slide gate at WS toe

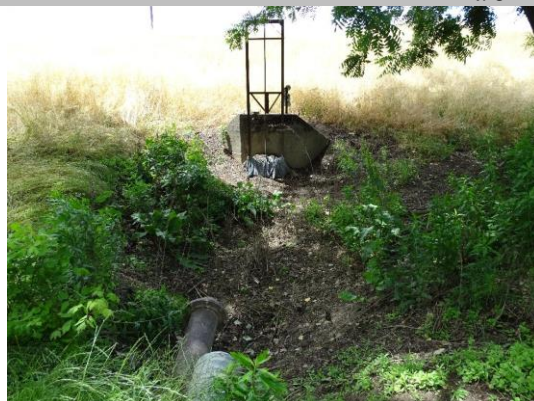
Photo 3 of 3 : UCIP_SP_2020_54215_79901.jpg

Slide gate at WS toe and sump area in front of slide gate

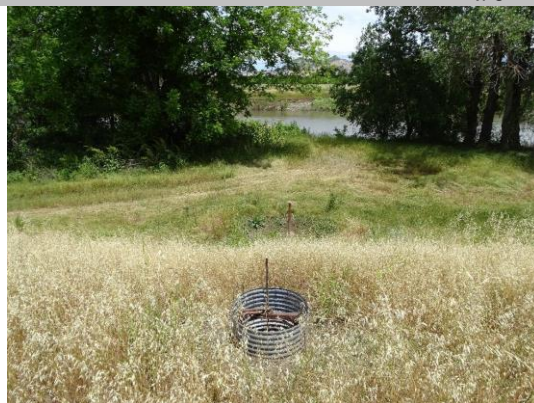
Photo 1 of 3 : UCIP_SP_2020_54216_79906.jpg

DS_ID:20288
 FS_ID:54216
 EP_NO: N/A
 Repair Type: Non-Urgent
 Crossing Status: Found
 UCIP Comments: 05/22/2019 CMP riser on WS shoulder missing a cover that creates fall hazard. A new electrical conduit is noticed on WS berm near pipe alignment. (O.Yakimov - DWR UCIP)
 FIELD_STRUCT_DESC: 24-inch drainage pipe of an unknown material through the levee, 19 feet below the crown. 6-foot diameter corrugated metal standpipe on the landside (LS) toe. Pump and 24-inch pipe on the LS. Slide gate in corrugated metal riser unit on waterside (WS) slope. Concrete block wall at WS toe for discharge line. (Modified under Permit No. 8587, 1973 - Anthony E. Steidlmayer). [Additional Reference(s): DWR Levee Log, 2006. USACE Sacramento O&M Manual 131, May 1960 (HLM 41.56)].
 FS Date: 5/22/2019 2:35:19 PM

Corrugated metal riser on WS shoulder

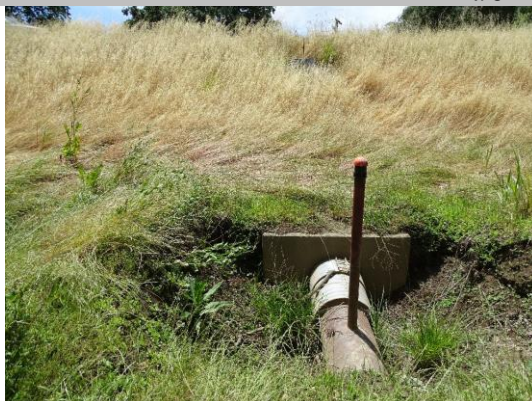
Photo 2 of 3 : UCIP_SP_2020_54216_79904.jpg

Concrete block wall at WS toe

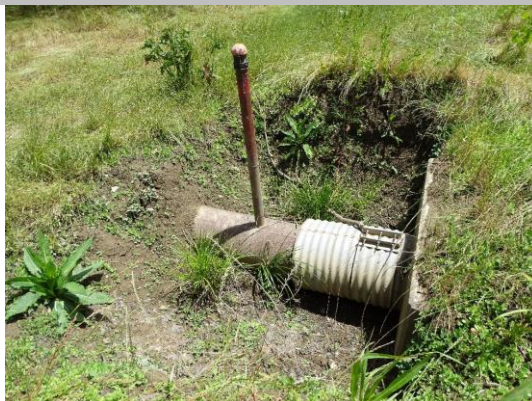
Photo 3 of 3 : UCIP_SP_2020_54216_79903.jpg

Siphon breaker on pipe at WS toe

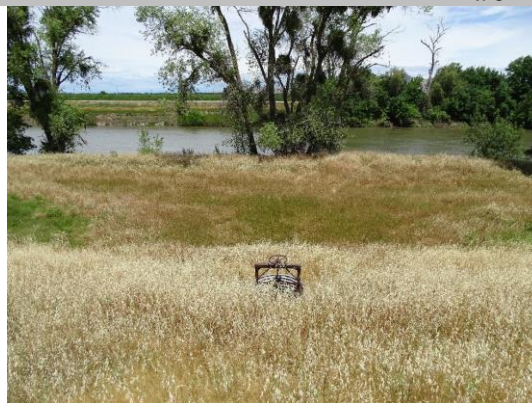
Photo 1 of 3 : UCIP_SP_2020_54217_79908.jpg

Comment Code						
Inspector Comment						
DS_ID:20289 FS_ID:54217 EP_NO: 9341 Repair Type: Non-Urgent Crossing Status: Found UCIP Comments: 05/22/2019 Uncovered CMP riser on WS shoulder is too low. Potential fall hazard. Slide gate in CMP riser buried in soil and not operable. (O.Yakimov - DWR UCIP)03/21/2013 Appears abandoned. Needs to be abandoned properly. FIELD_STRUCT_DESC: 30-inch irrigation pipe of an unknown material through the levee, 19.5 feet below the crown. Slide gate in a 36-inch corrugated metal riser unit on the waterside (WS) slope. (Automatic Board Order (ABO) issued as Permit No. 9341, 1974 - F. J. Steidlmayer). [Additional Reference(s): DWR Levee Log, 2006. USACE Sacramento O&M Manual 131, May 1960 (HLM 42.37)]. FS Date: 5/22/2019 3:32:10 PM

WS slope with 36-inch CMP riser

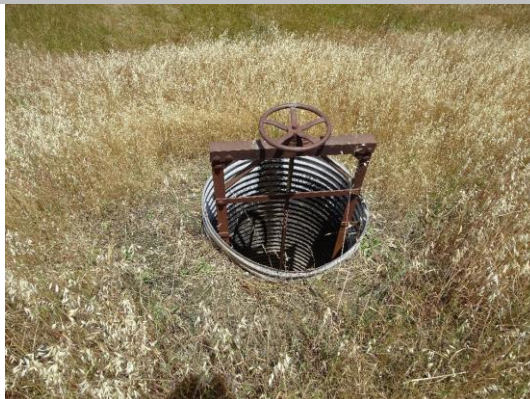
Photo 2 of 3 : UCIP_SP_2020_54217_79909.jpg

Missing cover of CMP riser

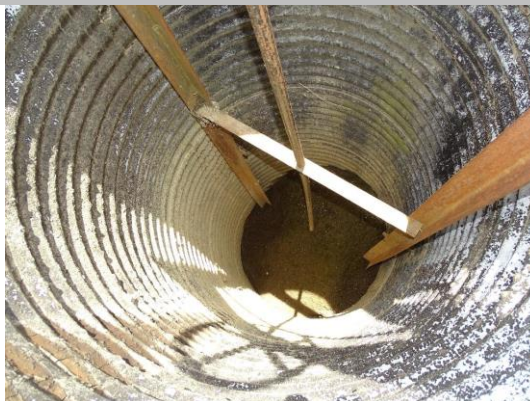
Photo 3 of 3 : UCIP_SP_2020_54217_79910.jpg

Inside view of CMP riser WS slope. Slide gate is covered with soil

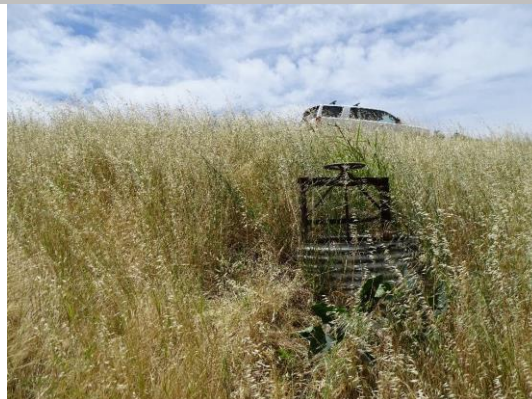
Photo 1 of 3 : UCIP_SP_2020_54218_79914.jpg

DS_ID:20290
FS_ID:54218
EP_NO: 9341
Repair Type: Non-Urgent
Crossing Status: Found
UCIP Comments: 05/22/2019 No issues recorded during inspection (O.Yakimov - DWR UCIP)
FIELD_STRUCT_DESC: 30-inch corrugated metal irrigation pipe through the levee, 19.5 feet below the crown. Slide gate inside a corrugated metal riser unit on the waterside (WS) slope. Pipe discharges into a concrete distribution box at a canal on the landside (LS) toe. (Automatic Board Order (ABO) issued as Permit No. 9341, 1974 - F. J. Steidlmayer). [Additional Reference(s): DWR Levee Log, 2006. USACE Sacramento O&M Manual 131, May 1960 (HLM 42.98)].
FS Date: 5/22/2019 3:50:26 PM

CMP riser on WS slope

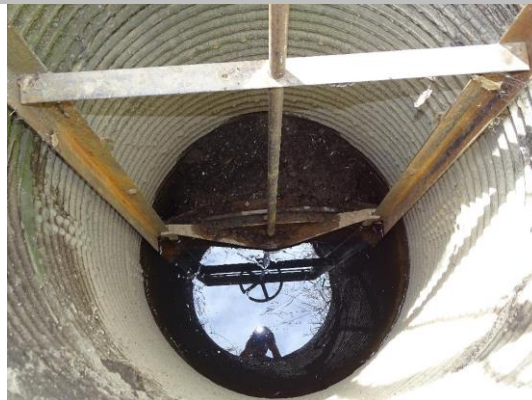
Photo 2 of 3 : UCIP_SP_2020_54218_79913.jpg

Inside view of CMP riser on WS slope

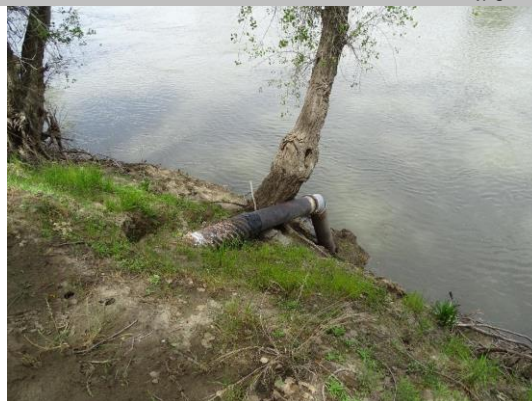
Photo 3 of 3 : UCIP_SP_2020_54218_79915.jpg

Pipe at river's edge

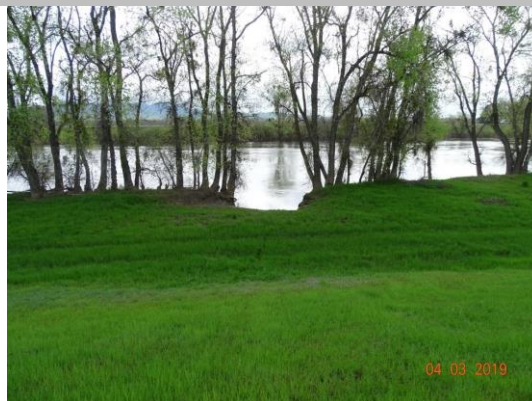
Photo 1 of 1 : SP_2020_NA0016_435_119_20200228_00048.jpg

LM Start	42.47	Rating **	A/W	Issue No.	119
LM End	42.47	Issue Type +	Ma	Location *	WS
Category	Earthen Levee			GPS Latitude/Longitude	
				Start	End
Item	Erosion / Bank Caving			39.166313 °	39.166313 °
				-121.937546 °	-121.937546 °
DWR ID	DWR_NA0016_01_s_2019_119				
Comment Code					
E1 : Note and monitor erosion site.					
Inspector Comment					
Erosion on the waterside berm. Recommend monitoring.

View of erosion from the crown. Spring 2019.

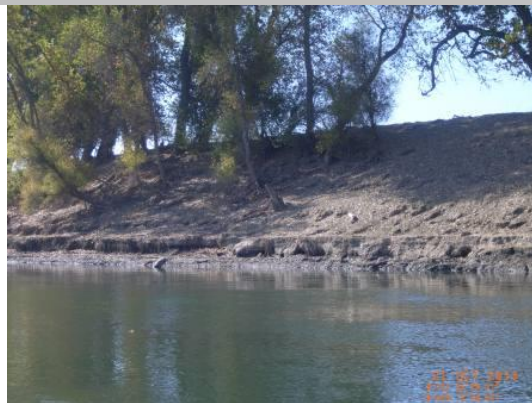
Photo 1 of 1 : SP_2020_NA0016_435_95_20200228_00028.jpg

LM Start	42.90	Rating **	A/W	Issue No.	95
LM End	43.09	Issue Type +	Ma	Location *	WS
Category	Supplemental			GPS Latitude/Longitude	
				Start	End
Item	2017 USACE Erosion Survey			39.172501 °	39.174949 °
				-121.939053 °	-121.940737 °
DWR ID	DWR_NA0016_01_f_2018_95				
Comment Code					
Inspector Comment					
2017 Site ID: SAC 136.6 R					
Status: Eroding					
2017 Field Notes: New erosion observed along the entire bank slope.					
Site History: 2010 - Lower portion of 136.7 that did not extend far enough. Abrupt transition from upstream site. 2012 - Site extended upstream, minor new erosion. 2013 - Minor new erosion at the toe.					
New tree popout. Downstream limit extended. 2016 - Site continues to worsen, fresh erosion at toe.

USACE 2013 Photo #1

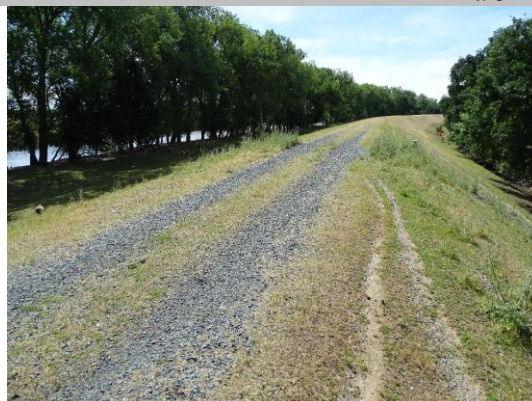
Photo 1 of 3 : UCIP_SP_2020_54219_79919.jpg

Comment Code						
Inspector Comment						
DS_ID:25485 FS_ID:54219 EP_NO: N/A Repair Type: Non-Urgent Crossing Status: Found UCIP Comments: 05/23/2019 Unauthorized encroachment. (O.Yakimov - DWR UCIP)05/23/2018 Contacted NA0016 superintendent about history and current status of the crossing. Confirmed that LMA has no additional information about this crossing that was put in before spring of 2017 (DWR UCIP-O.Yakimov) FIELD_STRUCT_DESC: 4-inch polyvinyl chloride (PVC) irrigation pipe through the levee, of an unknown depth below crown. Siphon breaker off landside (LS) shoulder. The pipe irrigates landscape on the waterside of the levee and is not permitted. Pipe found by DWR inspector Zach Jojola during Spring 2017 inspection. FS Date: 5/23/2019 4:05:59 PM

Levee crown at crossing

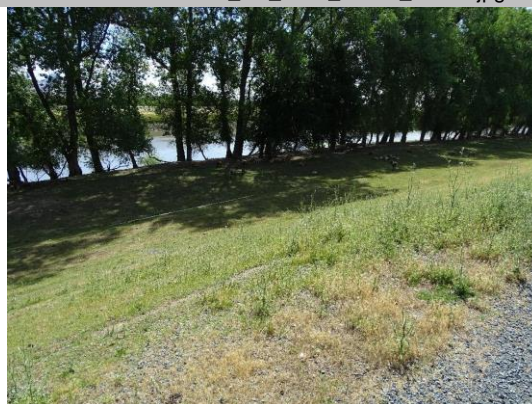
Photo 2 of 3 : UCIP_SP_2020_54219_79920.jpg

WS slope at crossing

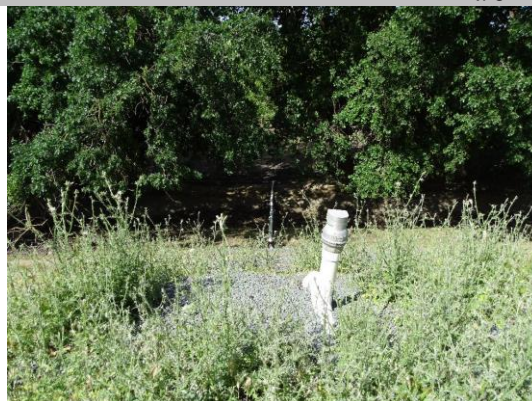
Photo 3 of 3 : UCIP_SP_2020_54219_79921.jpg

Air vent on unauthorized PVC pipe through the levee

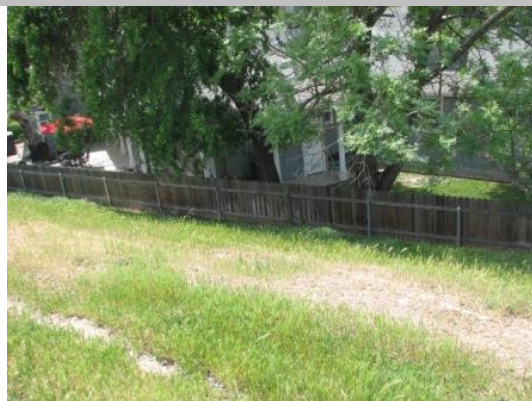
Photo 1 of 1 : SP_2020_NA0016_435_46_20200228_00015.jpg

LM Start	43.24	Rating **	U	Issue No.	46
LM End	43.24	Issue Type +	En	Location *	LS
Category	Earthen Levee			GPS Latitude/Longitude	
				Start	End
Item	Encroachments			39.176429 °	39.176429 °
				-121.942889 °	-121.942889 °
DWR ID	DWR_NA0016_01_s_2012_46				
Comment Code					
FE : Fence					
Inspector Comment

A solid fence along the toe of the levee. Photo taken spring 2012.

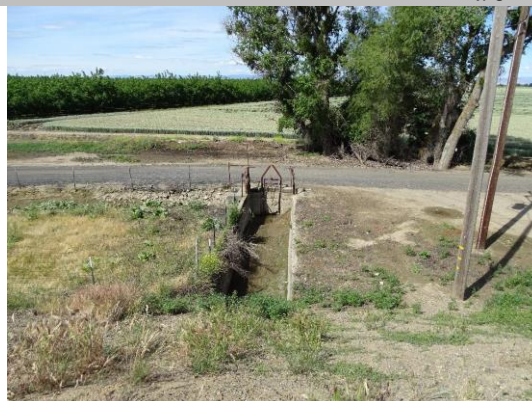
Photo 1 of 3 : UCIP_SP_2020_54221_79924.jpg

Comment Code						
Inspector Comment						
DS_ID:20292 FS_ID:54221 EP_NO: 9344 Repair Type: Non-Urgent Crossing Status: Found UCIP Comments: 05/23/2019 No issues recorded during inspection (O.Yakimov - DWR UCIP) FIELD_STRUCT_DESC: 2 of 3: 4-foot by 5-foot reinforced concrete box irrigation culvert through the levee, 21 feet below the crown. Slide gate inside a concrete surge box at the waterside (WS) toe. Pump in pump house on the WS slope. Steps on the WS slope. Discharges into a concrete box on the landside (LS). Wash in rock on the WS slope, 4 feet in depth from 36-inch overflow pipe from pump. (Automatic Board Order (ABO) issued as Permit No. 9341, 1974 - F. J. Steidlmayer). [Additional Reference(s): DWR Levee Log, 2006. USACE Sacramento O&M Manual 131, May 1960 (HLM 44.05)]. FS Date: 5/23/2019 11:52:31 AM

LS slope and concrete structure at LS toe

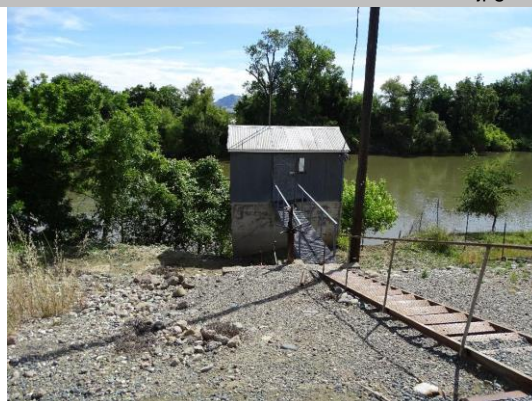
Photo 2 of 3 : UCIP_SP_2020_54221_79925.jpg

WS slope, steps, and pumphouse on WS

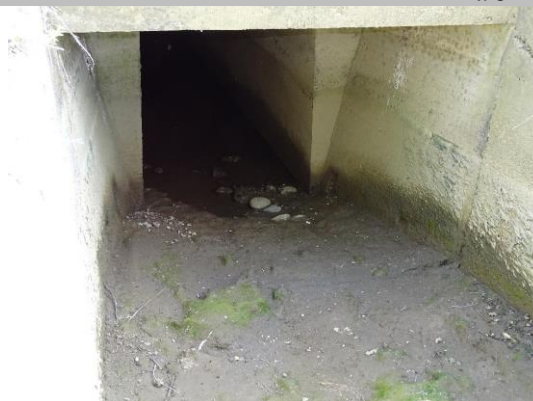
Photo 3 of 3 : UCIP_SP_2020_54221_79926.jpg

4'x 5' concrete culvert at LS toe

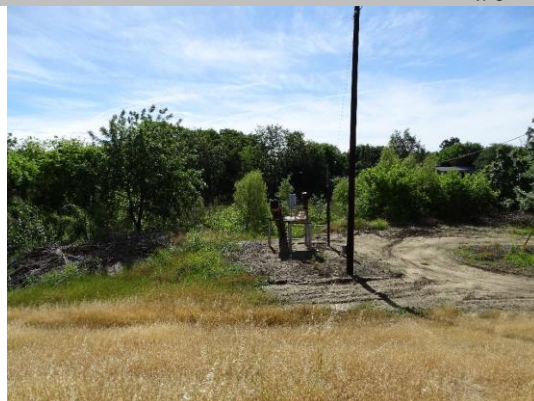
Photo 1 of 3 : UCIP_SP_2020_54223_79931.jpg

Comment Code						
Inspector Comment						
DS_ID:20293 FS_ID:54223 EP_NO: 5307 Repair Type: Non-Urgent Crossing Status: Found UCIP Comments: Uncovered CMP riser is too low. Potential fall hazard. Gap between concrete box and LS toe was filled with concrete. (O.Yakimov - DWR UCIP) FIELD_STRUCT_DESC: 2 of 2: 24-inch steel irrigation pipe through the levee, 5.3 feet below the crown. Metal cutoff wall. Slant pump on the waterside (WS) bank. Siphon breaker inside a 31-inch corrugated metal riser unit on the landside (LS) shoulder. Discharges into a concrete box at the LS toe. (Permit No. 5307, 1966 - George Steidlmayer). [Additional Reference(s): DWR Levee Log, 2006]. FS Date: 5/23/2019 1:18:17 PM

Pumping platform on WS berm looking from levee crown

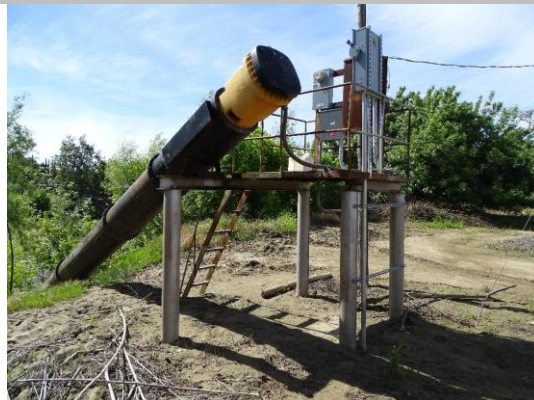
Photo 2 of 3 : UCIP_SP_2020_54223_79930.jpg

Slant pump on WS berm

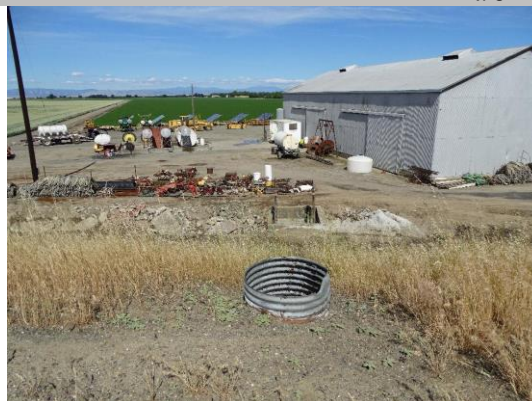
Photo 3 of 3 : UCIP_SP_2020_54223_79932.jpg

LS slope and CMP riser on LS shoulder

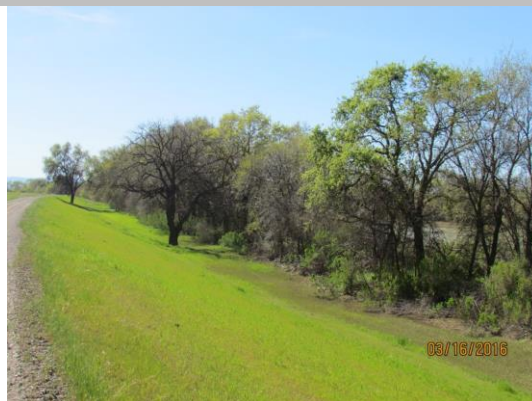
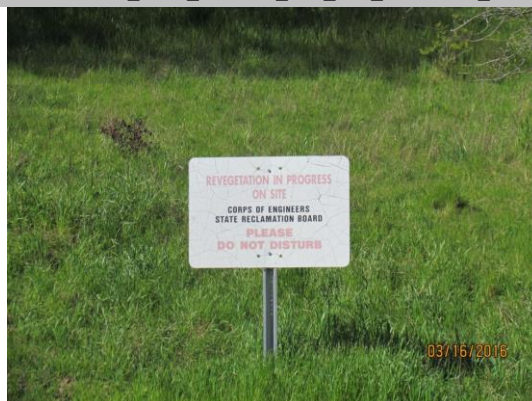
LM Start	45.39	Rating **	A/W	Issue No.	108
LM End	45.90	Issue Type +	Ob	Location *	WS
Category	Earthen Levee			GPS Latitude/Longitude	
				Start	End
Item	Vegetation			39.192653 °	39.188518 °
				-121.952768 °	-121.960446 °
DWR ID	DWR_NA0016_01_s_2015_108				
Comment Code					
V8 : Environmental Requirements.					
Inspector Comment

View of the revegetation site on the waterward side of the levee looking upstream. Spring 2016.

Sign stating revegetation site. Spring 2016.

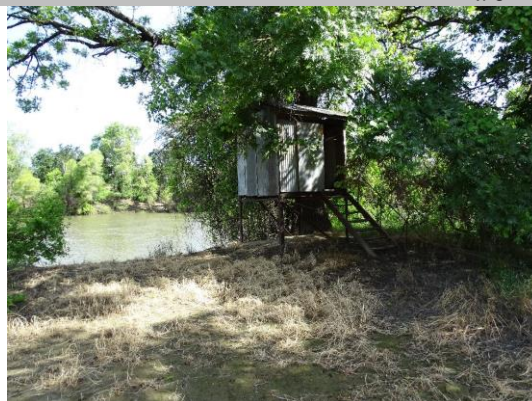
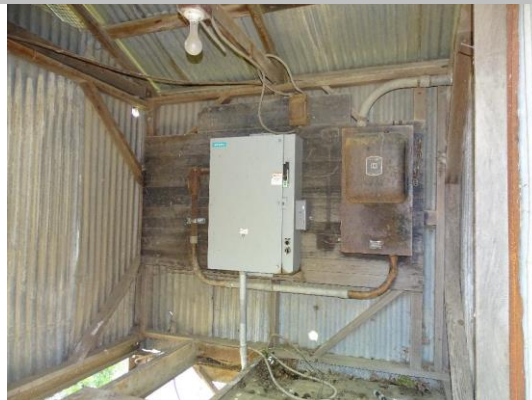
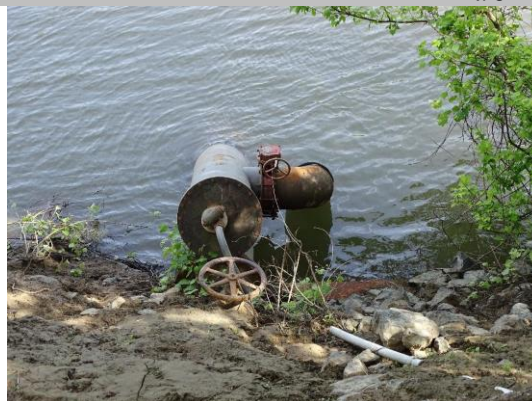
Comment Code						
Inspector Comment						
DS_ID:20294 FS_ID:54224 EP_NO: 9344 Repair Type: Non-Urgent Crossing Status: Found UCIP Comments: 05/23/2019 Pump is connected via overhead electrical line. No issues recorded during inspection. (O.Yakimov - DWR UCIP) FIELD_STRUCT_DESC: 3 of 3: 24-inch steel irrigation pipe through the levee, 5.7 feet below the crown. Pump in pump house on the waterside (WS) bank. Gate valve inside the pump house. Discharges into an irrigation ditch on the landside (LS). (Automatic Board Order (ABO) issued as Permit No. 9344, 1974 - George E. Steidlmayer). [Additional Reference(s): DWR Levee Log, 2006. USACE Sacramento O&M Manual 131, May 1960 (HLM 46.06)]. FS Date: 5/23/2019 2:00:17 PM

Old pumphouse on WS berm

Electrical panels inside old pumphouse

Intake pipe and shutoff valve at riverbank

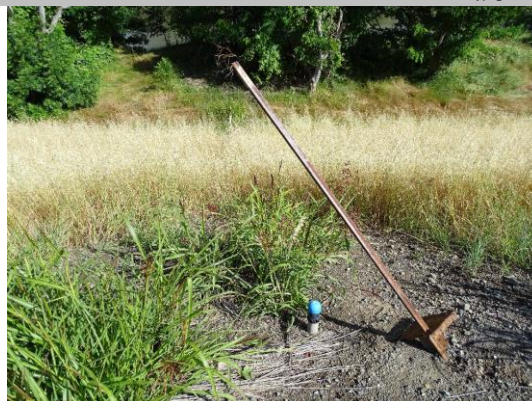
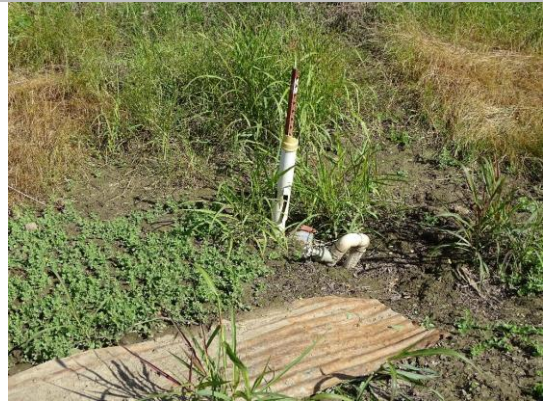
DS_ID:20314
FS_ID:54225
EP_NO: 15763
Repair Type: Non-Urgent
Crossing Status: Found
UCIP Comments: 05/23/2019 Found capped pipe at WS toe.
(O.Yakimov - DWR UCIP) Fresno valve on WS shoulder is broken.
Pipe appears to be abandoned. Need to abandon properly if necessary. site visit on 10/09/2015 indicates water is present somewhere along the waterside levee slope. Possibly siphon breaker or fresno valve sprays and drains down levee slope from WS shoulder. internal inspection of pipe recommended to determine source of leak.
Pipe is active, but can be removed and capped when not in use.
FIELD_STRUCT_DESC: 4-inch galvanized steel irrigation pipe through the levee, 2 feet below the crown. Irrigation valve approximately 50 feet landward of the landside (LS) toe. Fresno valve on the waterside (WS) shoulder with connection for pump at the WS berm. (Permit No. 15763, 1991 - Randy Salverson).
FS Date: 5/23/2019 2:15:08 PM

Siphon breaker/air vent on WS shoulder and levee slope

PVC line with shutoff valve and a capped pipe at WS toe

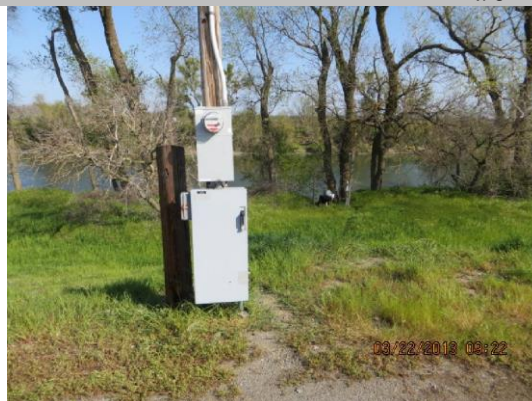
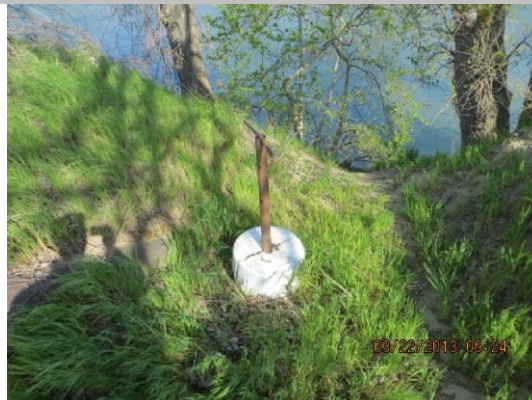
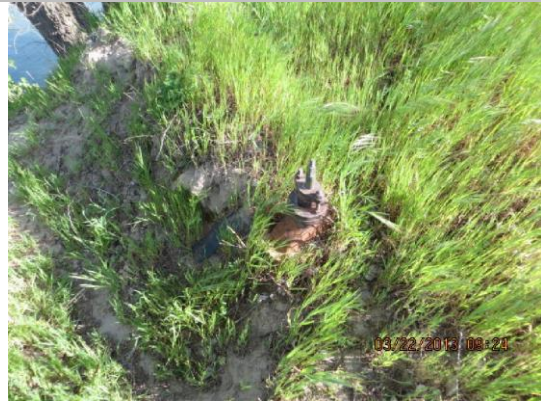
Comment Code						
Inspector Comment						
DS_ID:20295 FS_ID:54226 EP_NO: 9350 Repair Type: Non-Urgent Crossing Status: Found UCIP Comments: 05/23/2019 Erosion around concrete box at LS berm. (O.Yakimov - DWR UCIP) FIELD_STRUCT_DESC: 18-inch irrigation pipe of an unknown material through the levee, 21 feet below the crown. Gate valve and slant pump on the waterside (WS) bank. Switch board on the WS shoulder. Discharges into a 5-foot by 5-foot concrete distribution box on the landside (LS) toe. (Automatic Board Order (ABO) issued as Permit No. 9350, 1974 - W. H. Halsey). [Additional Reference(s): DWR Levee Log, 2006. USACE Sacramento O&M Manual 131, May 1960 (HLM 46.73)]. FS Date: 5/23/2019 2:34:30 PM

Electrical meter on LS shoulder and slant pump on WS berm.

Valve on WS berm.

Slide gate on WS berm.
